FIRE SERVICES  
COMMISSIONER  
VICTORIA

# TOWARDS IMPROVED FIRE MANAGEMENT IN LANDFILL SITES

A review by I.R.S Services  
July 2012

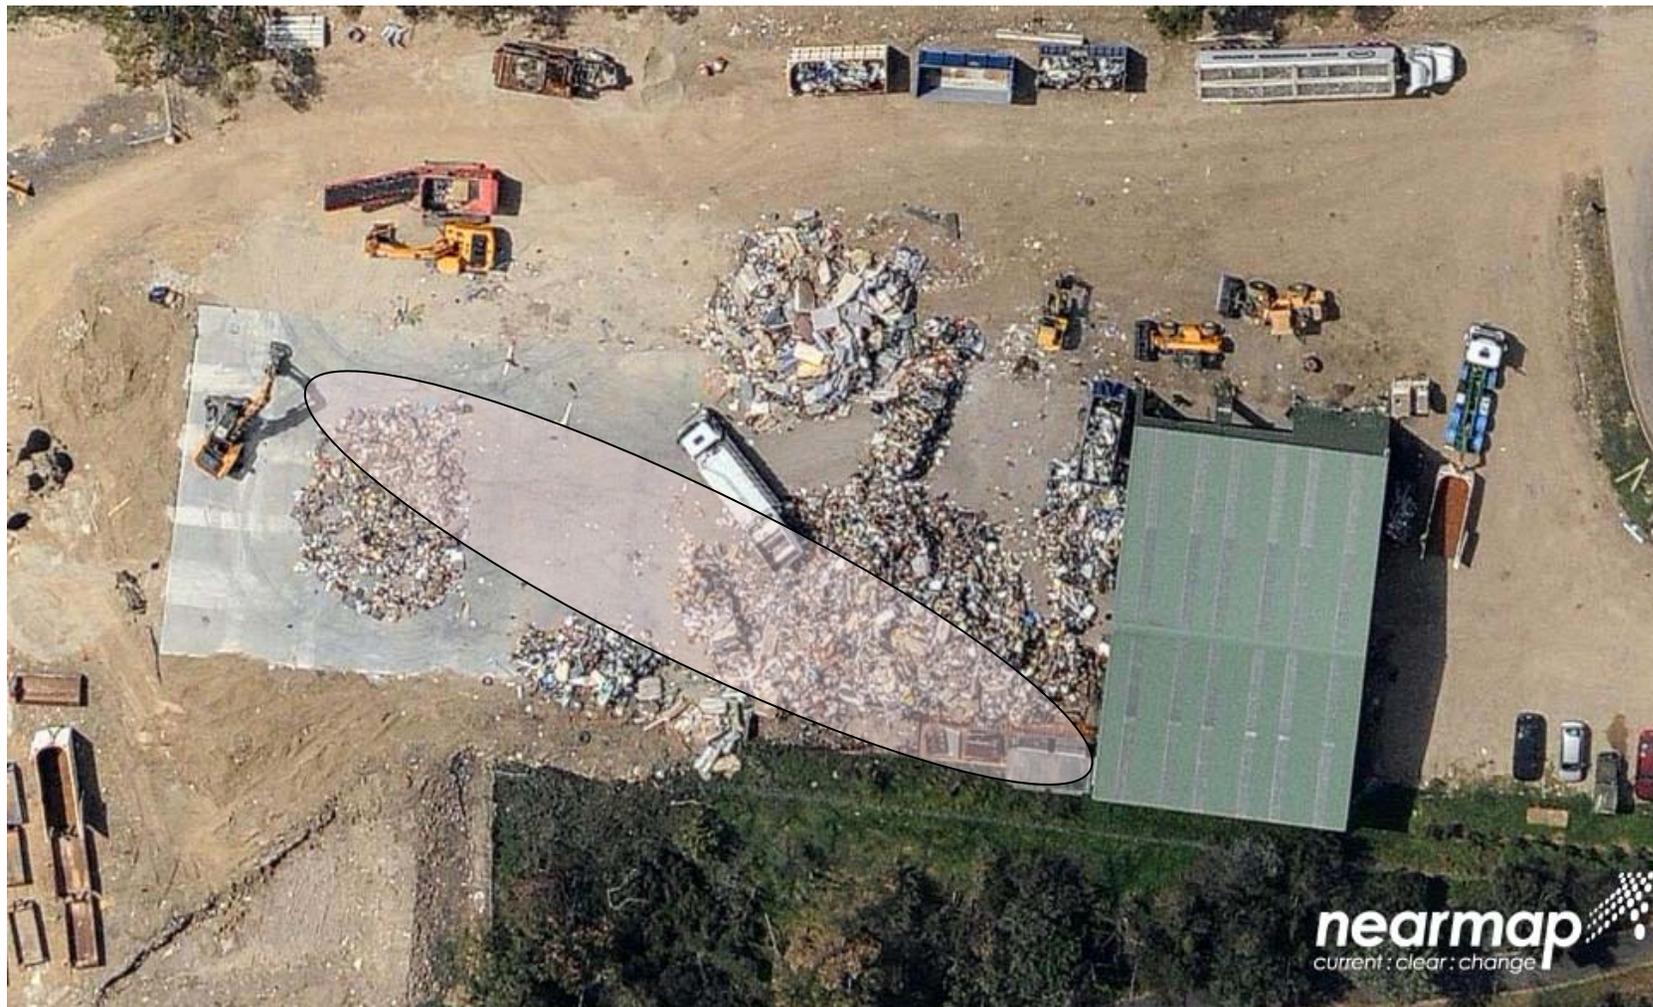
**Knox Transfer Station – Area where fire occurred. (image dated 15.02.12)**

The fire extended through the length of the continuous stack of waste and caused damage to the corner of a large shed and to an attached workshop fashioned out of old shipping containers. The building and workshop damage was considered to be valued at \$50,000.

Ignition was attributed to hot pieces of spring steel dropping from the machines conveyor with the other material. The transfer station manager told me that a powerful magnet designed to extract the metal had been removed from the machine because it regularly caused blockages.

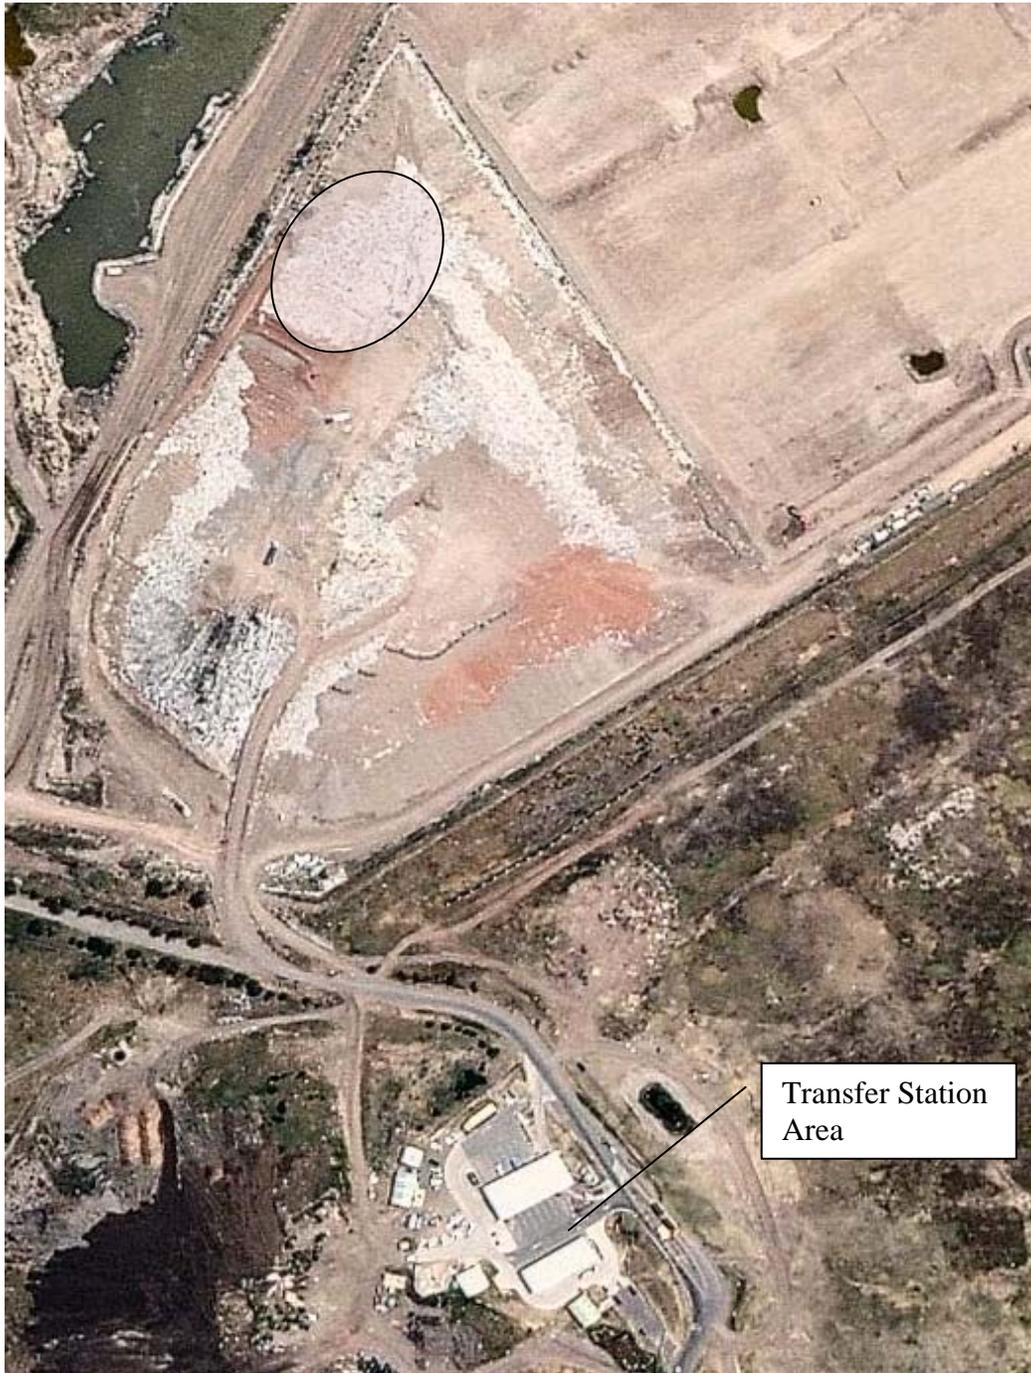
**Werribee Landfill – Showing transfer station and current landfill area**

The area involved in the fire has been circled. The substantial area of uncovered waste when this image was taken indicates that daily coverage of deposited waste is not always achieved.

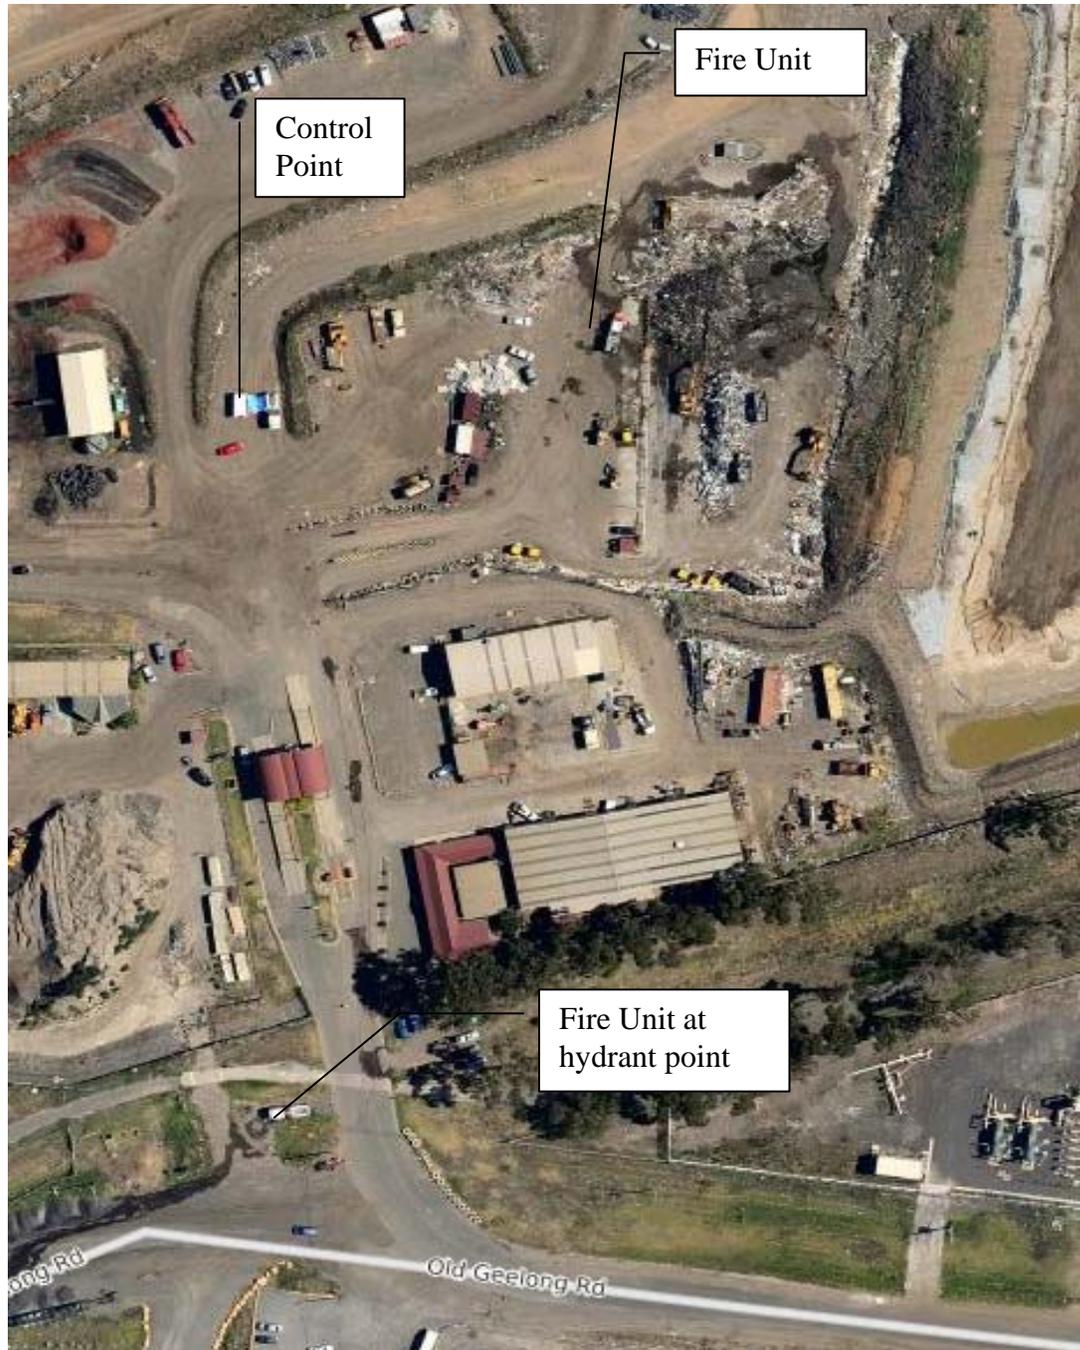
**Brooklyn Landfill Fire – (image taken 22.02.2012)**

The actual cause is not known but was thought to be the deposit of hot materials earlier in the day that caused smouldering ignition within the heap and flared once it reached the surface of the rubbish pile.

Fire Area can be seen in the image and units are still in attendance.
